Our first experience working alongside 3D scanning to check floor flatness compliance on a live project for a Robotics picking facility running on a composite metal deck.

Kevin Dare – Managing Director – Face Consultants Ltd

26th April 2021

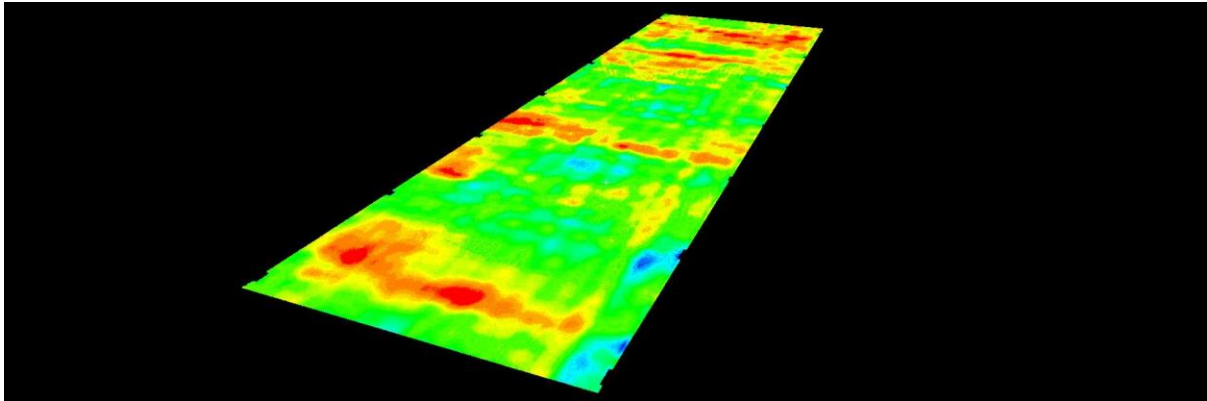
3D heat map of a typical mezzanine metal composite deck floor. “Pretty pictures”

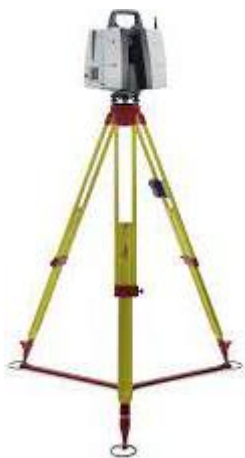
- Leica P40 Scanner used
- Scanner set up on a dolly for ease of site movement.
- 4 control points at either end of each panel length with another 4 control points on columns in the middle of the panel length. Panel length is about 150 metres long and 16 metres wide.
- Picking the control on the scanner from the first setup near the initial and last control points and then cloud to cloud registration on the rest.
- Scanner set at around a 2-minute scan time.
- Scanner set max. 10 metre centres.
- Total scan time for 2400 sq. m was about 3 hours.

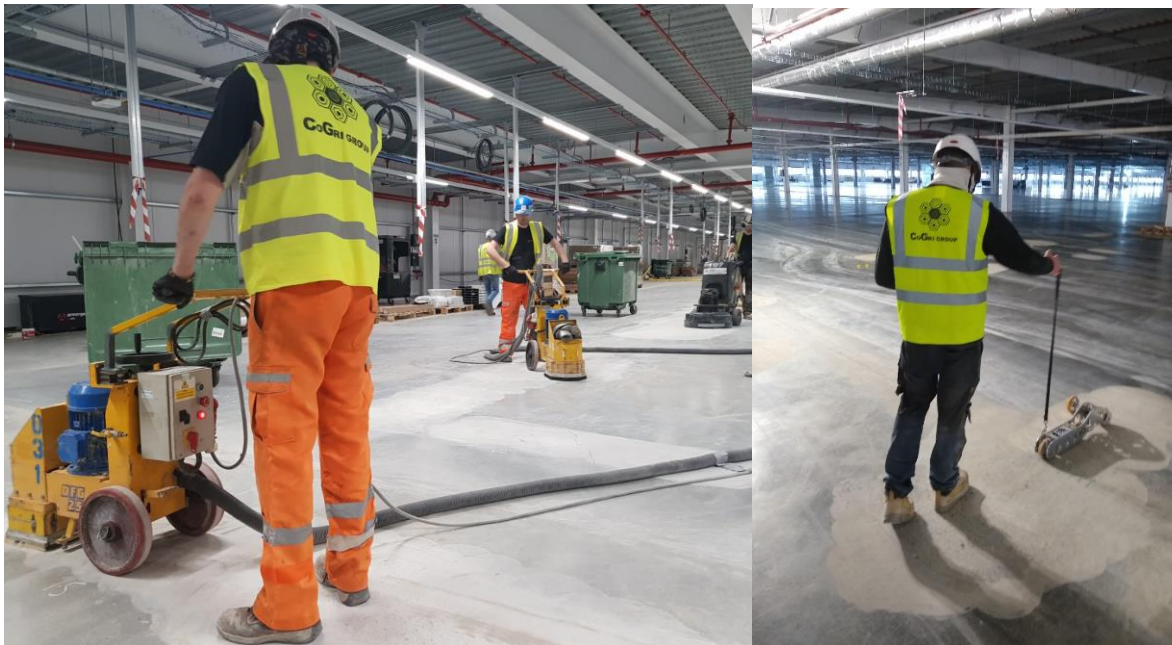
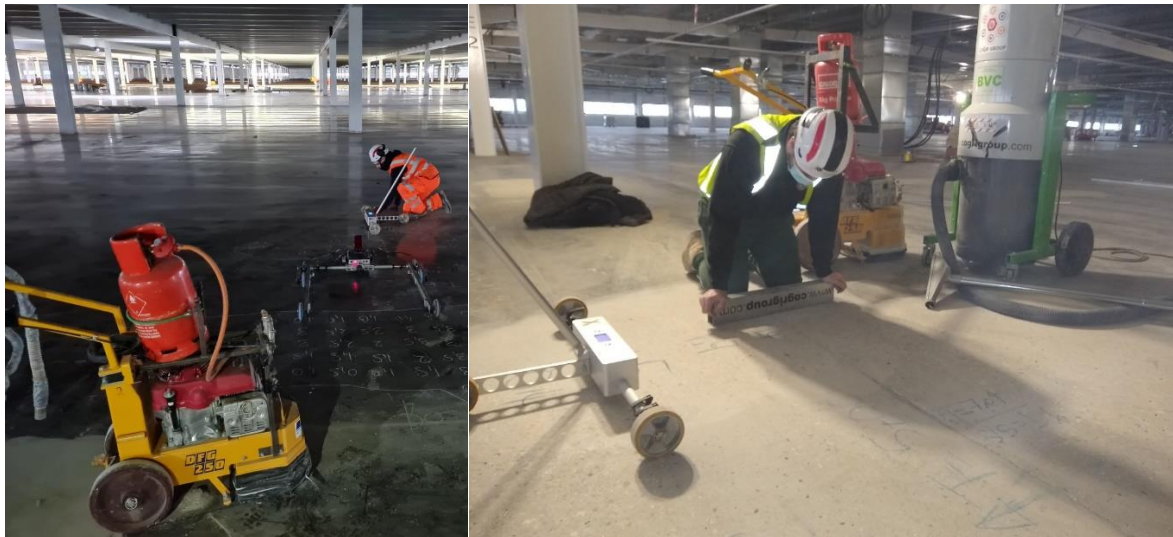
After a few days grinding, the experienced grinding crew started to ask questions as to the validity of the survey as they were struggling to find a lot of the errors that were marked. After about 4 weeks on site and struggling with the unusual volume of grinding works and a lack of onsite direction from the 3D scanning company, the Grinding crew decided to call in Face Consultants (Face) with their profileograph, with whom they are used to closely working with on previous projects, to help them validate the errors. It was found that 40% to 60% of the errors marked by the 3D scanning crew were in fact false positives. There were also errors not found with the 3D scanning process (false negatives). Probably due to the uncertainty level being set too low.

Top left, clockwise: Controlled grinding. Checking grinding with Prop II meter. Marking errors with profileograph and Transbar. Checking grinding with straightedge and Transbar.

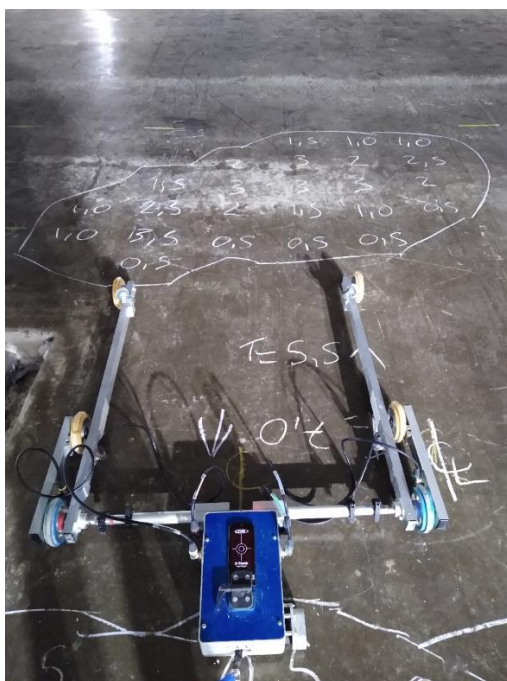
Profileograph used to mark required grinding.

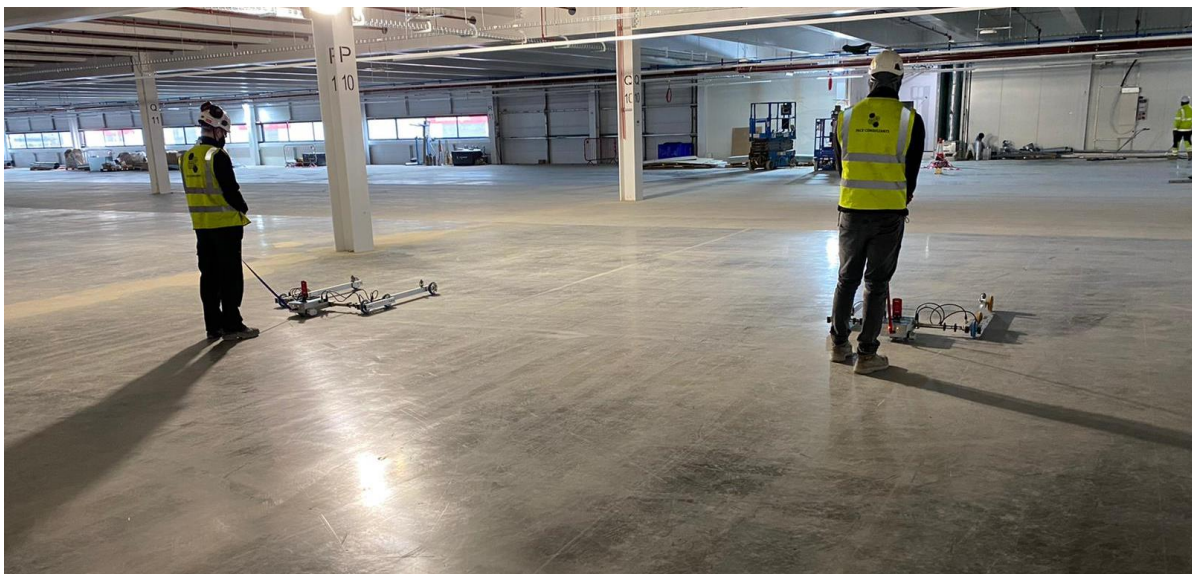
2 of the 8 profileographs used over the weekend to survey 28,000 sq. metres of floor (1m x 1m).
