JOINT ARRIS REPAIR DETAIL - Type 3 Repair

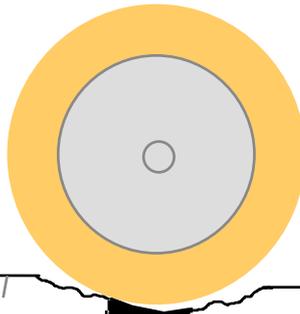
Existing problem

Hard wheels of materials handling equipment impact against the joint edges, initially creating and then increasing the extent of the damage.

Any slight step between adjacent floor slabs will exaggerate damage to the joint edges, or arrisses. Wheels, tyres and bearings all suffer damage due to the impacts endured as they travel across joints.

Existing joint sealant is typically too soft, compressed or de-bonded from the floor slab edges.

Wide joints suffer the most damage.

Joint sealant should be hard enough to withstand the impact loads from wheeled traffic and yet be flexible enough to allow movement in the floor slabs.

A 35mm deep saw cut is made around the perimeter of the proposed repair. i.e. No feather-edge to the repair mortar

The repair and adjacent floor surface will be ground smooth to ensure a smooth transition for wheeled traffic.

New 5mm wide joint width is fully filled with a suitable joint sealant ('Shore A' hardness of 65 - 80)

Repair depth to be a minimum of 35mm.

All surfaces of the joint cavity are primed, with an epoxy bonding agent, prior to filling with the repair mortar.

The repair mortar replaces the damaged corners of the concrete floor slabs

Typical repair width of 100 to 120mm, determined by extent of existing edge damage.

The min. 20mm deep joint sealant is given additional support from a polyethylene backing bead that is inserted into a 5mm wide saw cut through the cured repair mortar. Alternatively a 'cast in place' polystyrene joint former can be used, in lieu of the backing bead and saw cut.

Joint repair base to be roughly scabbled to provide a good mechanical bond between the floor and the repair materials.

Any existing joint material can be retained beneath the repair.
