FASTRACK JOINT REPAIRS KEEP ESTERFORM MOVING

[CG Flooring Systems](#) were challenged by [Esterform Packaging](#) to complete repairs to their floor whilst they were still operating all within a one-day window.

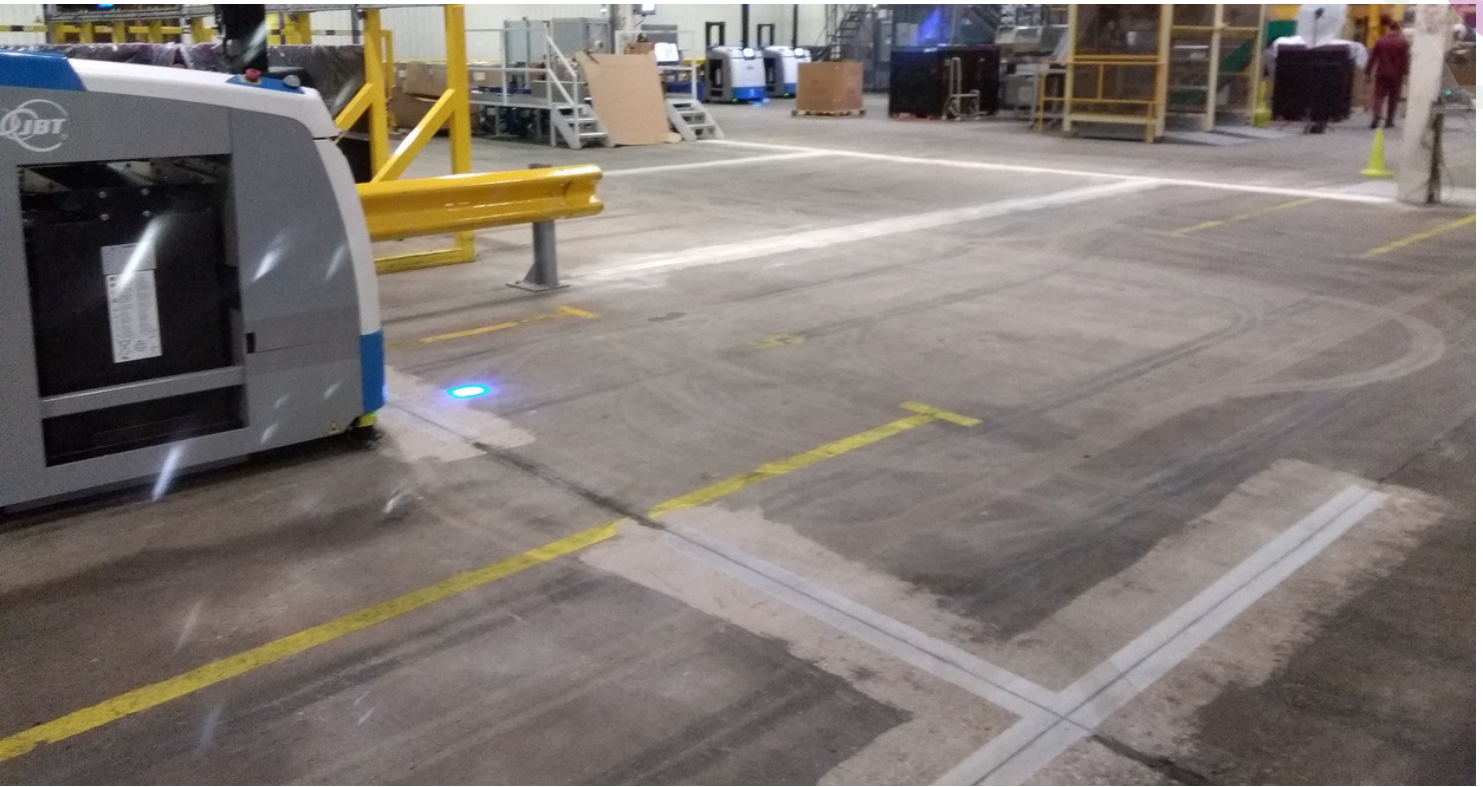
Esterform's operation runs 24/7 364 days a year with automated guided vehicles (AGV's) running in fixed routes around the warehouse. They had upgraded to the AGV's earlier in the year but were unable to run at full speed due to the poor condition of the floor joints. The joints were pretty wide, averaging around 20mm, causing the AGV wheels to impact on the exposed arris edge of the joint.

This results in damage to the slab edges, which in turn ensures a bumpy ride for the AGV's as they pass over the joints.

A plan was agreed to complete a total of 70 linear metre of [arris repair](#) within a day shift diverting the AGV's until areas had been completed to keep the operation running whilst carrying out the repairs. Using [CoGri Rapid Mender](#), our fast curing, industrial repair mortar, which can be opened to traffic within one hour of application, ensured we could complete the task within the operational window, with confidence.

As soon as the joint repairs were completed, the floor was opened to traffic and it wasn't long before the AGV's were running at optimum speed across the floor. Of particular note was how quiet and smooth the ride was over the new joint arris repair details.

CG Flooring Systems repaired the damaged joints with our tried and tested arris repair detail, using our premium quality [CoGri repair materials](#).
