## CG FLOORING'S SOLUTION TO A FLOOR HEAVE PROBLEM

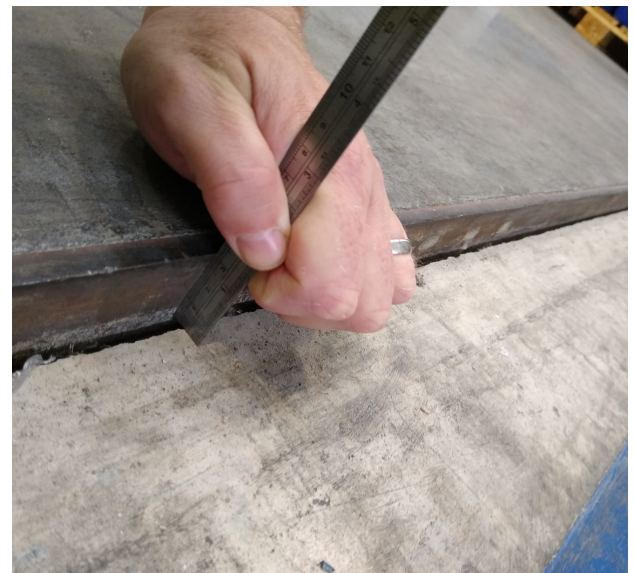
The floor of their industrial unit was demonstrating heave in a localised area, which was impacting the ability of the operation to perform at an optimum level.

The warehouse floor slab directly in front of the loading bays was higher in one section than the loading bay dock levellers. At its highest point, there was a 30mm stepped edge off the warehouse floor onto the loading bays.

It was believed to have been caused by piles put in after construction of the floor slab, displacing the original sub-base material adjacent to the pre-cast dock levellers as they were placed. This left the sub-base material nowhere to go except up, pushing the slab upwards with it.

CG Flooring, therefore, had to provide a repair solution. This included the controlled reduction of the levels of the slab within a very defined area of 90m<sup>2</sup>, flattening, smoothing, and aligning the two adjacent floor areas.

The first step was for CG Flooring to remove the steel angle - used to protect the slab arris edge at the floor slab, at the interface with the dock levellers. A joint arris repair was performed, using CoGri Arris Repair Mortar to remove the pronounced step at the joint interface. Further joints were repaired within the designated area. Using our standard repair detail to remove the steel top section of the armour joint the void was filled with our repair mortar before reinstating the joint using our CoGri Rapid Seal 75 joint sealant. Our repair materials are durable and ductile, designed to stand up to the heavy traffic movements of the materials handling equipment (MHE) that pass over the floor.

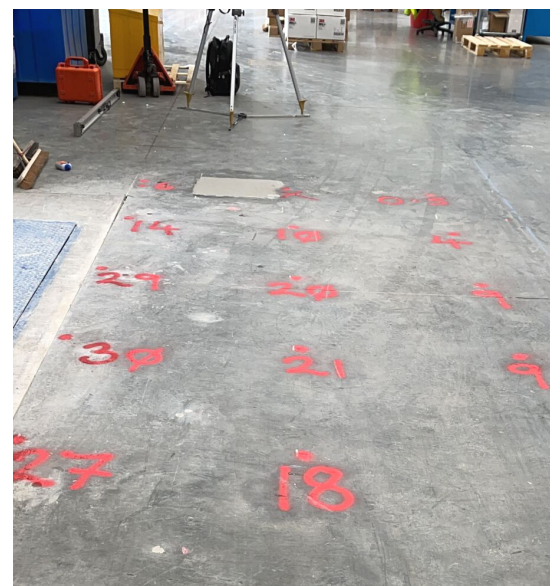
As demonstrated in the images above, there was a significant amount of mechanical planning / scabbling to be completed.

To ensure we provided the best solution for our client, we engaged our sister company, Face Consultants, to carry out a flatness survey and control the reduction in level work to the floor area. The survey results enabled the Face surveyor to identify the areas to be prepared by planning and grinding.

With these areas marked, the planning and grinding work was carried out in a dust-free manner. Under the watchful eye of the Face Surveyor, the desired floor levelness and flatness to best support the warehouse operation was achieved.

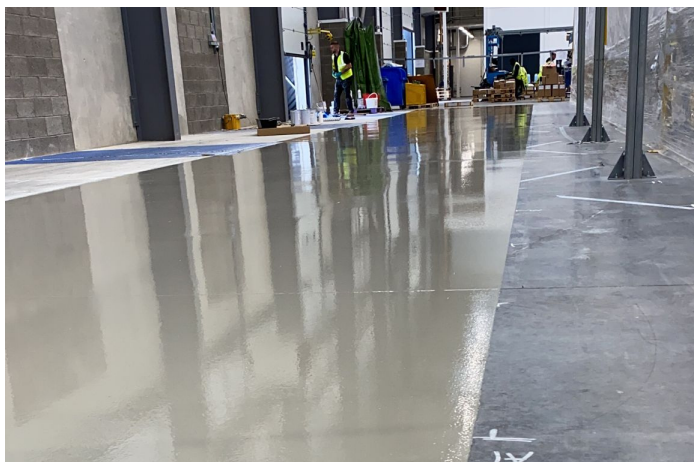
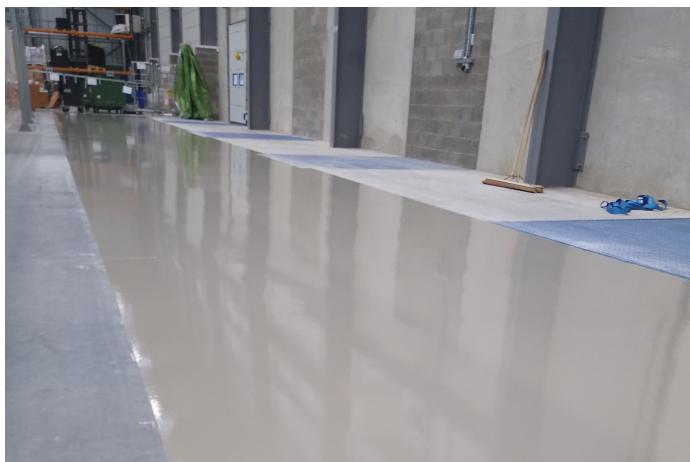
A further process of vacuum enhanced grinding was carried out to provide a smooth finish to the concrete. CoGri High Build solvent-free epoxy resin floor coating was then applied in the clients' preferred colour. Resin floor coatings not only deliver an aesthetically pleasing finish but also offer protection where needed, such as chemical resistance, anti-slip surfaces, and abrasion resistance. Surfaces are hygienic, easy to clean and maintain, and available in a gloss or matt finish.
