Our first experience working alongside 3D scanning to check floor flatness compliance on a live project for a Robotics picking facility running on a composite metal deck.

Kevin Dare – Managing Director – Face Consultants Ltd

26th April 2021

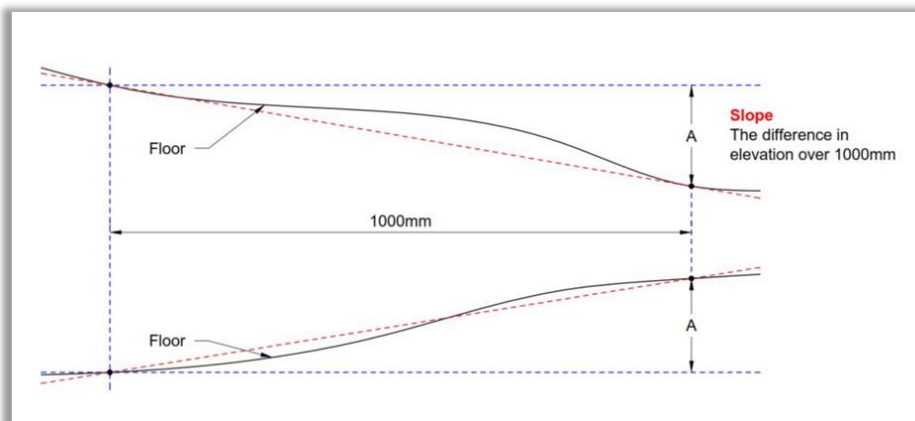
Property 1

The maximum values of the properties were reduced to accommodate an uncertainty value (inaccuracy) of the 3D scanning process. The value of uncertainty declared by the scanning company on this project was **0.8mm**. Although this maybe the uncertainty of the z value (optimistic) it is not the uncertainty value that should be used for each of the property limits, but 0.8mm was used on all 3 properties.

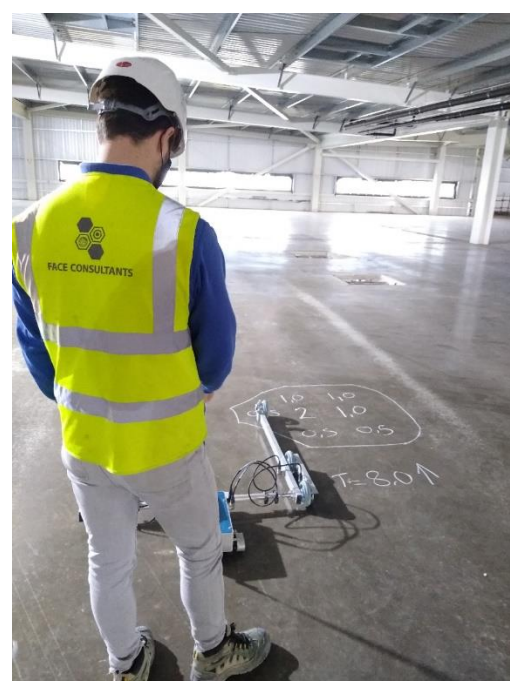
Profileograph used to mark required grinding.
