## LABORATORY FLOOR TRANSFORMATION

### About The Client:

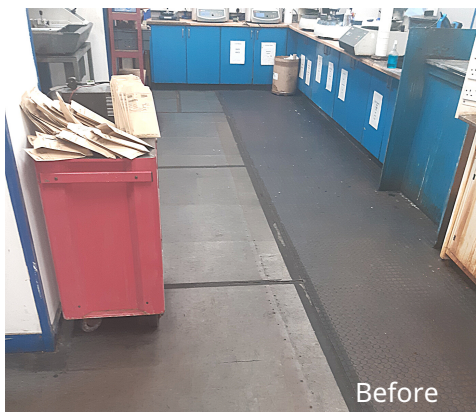
Before

They were looking to remove the worn vinyl floor and the wooden boards it was applied to, exposing the concrete floor underneath. They could then ensure that the floor was workable and suitable for carrying out their daily operations efficiently and safely.

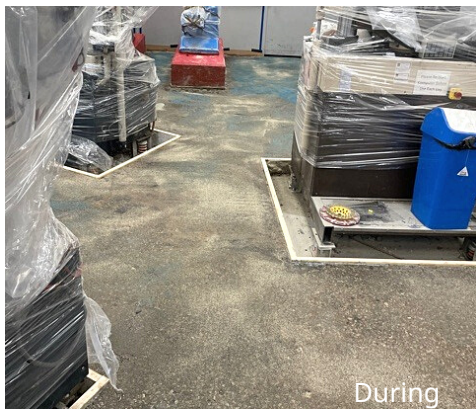
During

Understanding the brief and creating a cost-effective plan based on our client's requirements, we worked closely with our supplier who provided a **Heavy Duty Polyurethane (PU) floor screed** for the new floor system. However, selecting the wearing system was the straightforward part of the project, with the unknown condition of the concrete substrate now the main challenge in front of us. Despite hoping for the best outcome, the surface of the slab required additional work to get it ready to receive the PU screed.

Following clear and open communication with the client, CG Flooring's proposed solution was accepted. Isolated repairs were carried out, including grinding the floor, repairing the ground slab, and lastly applying **CoGri FASTFLOOR-IT Industrial Base Screed** to level out the floor area of 265 square metres. The finished floor, in the preferred RAL colour, was delivered with minimum impact on the clients operation.

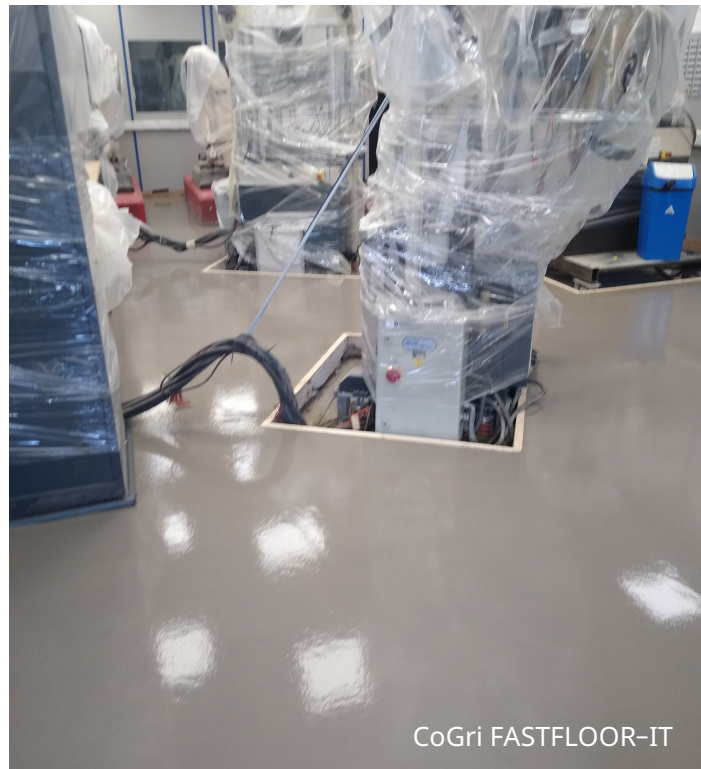
CoGri FASTFLOOR-IT

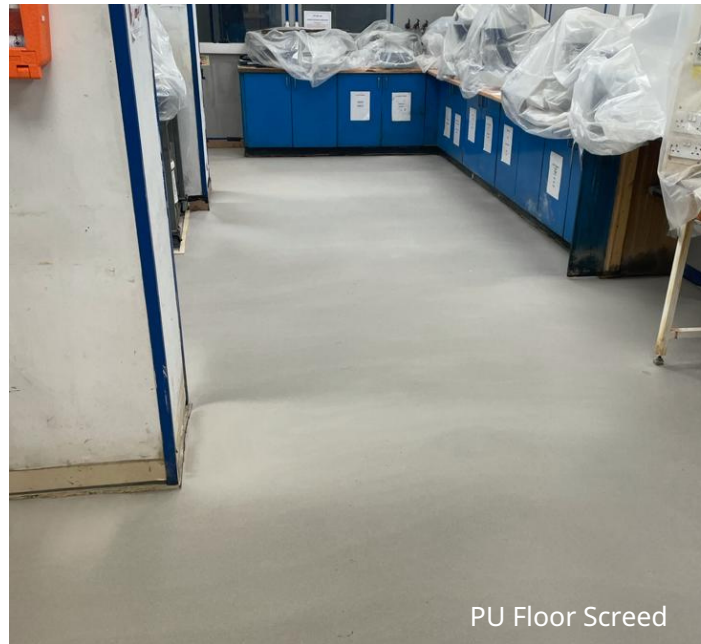
PU Floor Screed

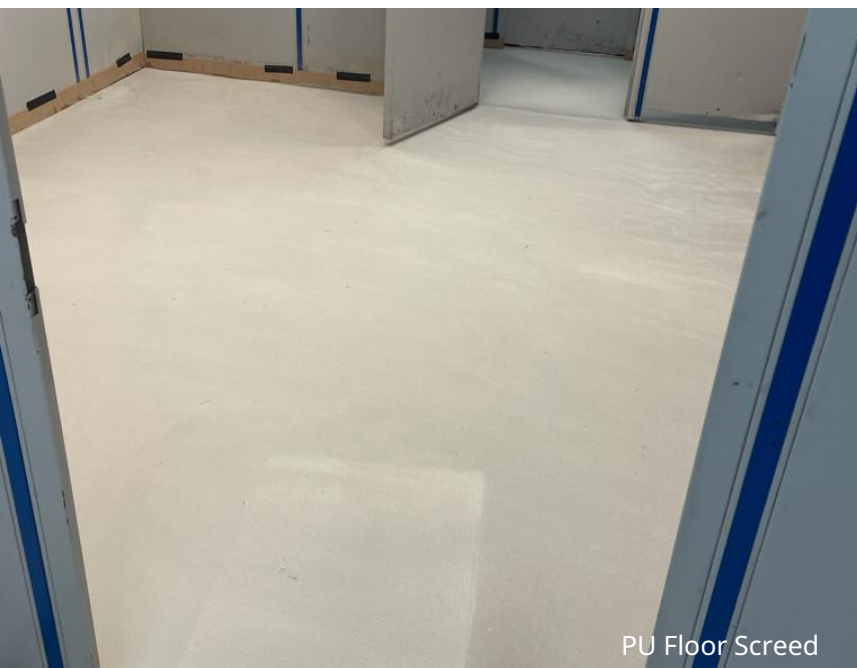
PU Floor Screed
