CG FLOORING SYSTEMS LTD  
Specialists in Industrial Flooring

## FILLING THE VOID WITH RAPID SEAL 75

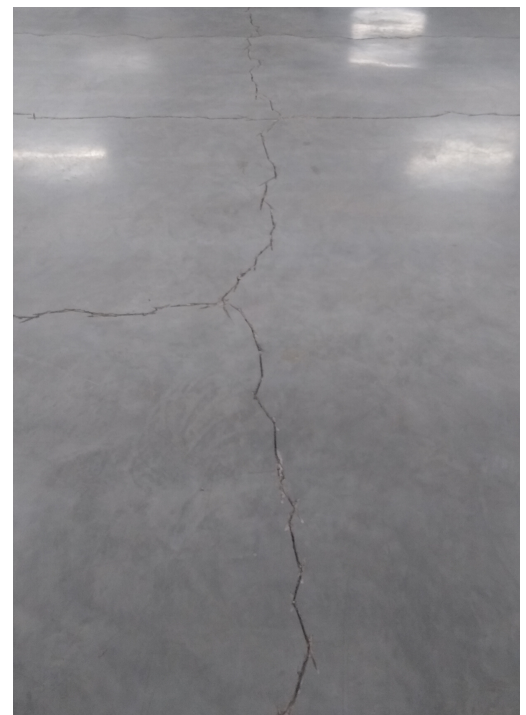
Their client, a leader in the global automotive industry, recently contacted them expressing concerns over cracks that appeared in an area of their vehicle storage facility.

**1. Existing Concrete Floor Crack**

As specialists in the **repair of concrete warehouse floor slabs**, CG Flooring Systems were asked to assess the cracks and provide a solution. After inspection it was decided that the floor area, on a mezzanine level, was in good condition. Also, that the cracks were not considered to be structural and would not affect the ability of the slab to carry its designed load.

With CG Flooring Systems being the perfect fit to carry out the project, open communication with the client helped us to understand what they were looking for. It was decided that **CoGri Rapid Seal 75** would be the best solution to fill the void.

This repair material is rapid curing, hard wearing, but flexible enough to cope with some movement within the slab. It can also be finished flush with the surrounding floor surface, without needing to grind the material down.

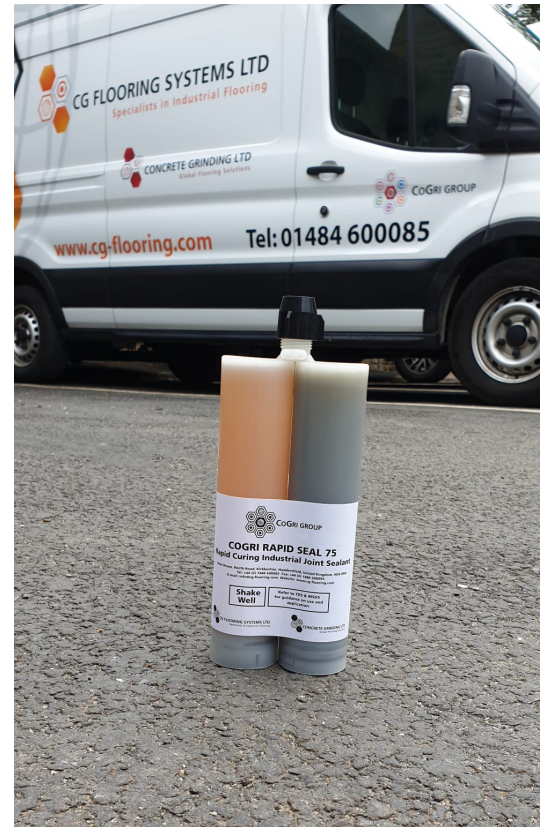
### 2. CoGri Rapid Seal 75

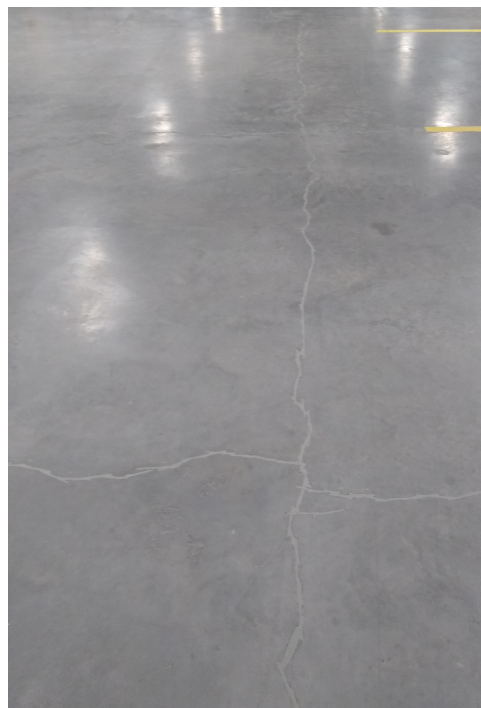
### 3. Repaired Concrete Crack

This solution helped return the floor to a serviceable condition, providing a neat finish that will significantly reduce the risk of damage to the arrisses of the cracks from hard wheeled vehicles in the future.
